SURVEYOR III PARTS AND MATERIALS/EVALUATION OF LUNAR EFFECTS

RETURNED FROM THE MOON BY APOLLO XII

SUBMITTED 22 JANUARY 1971

P 70-54
(SSD 00628R)

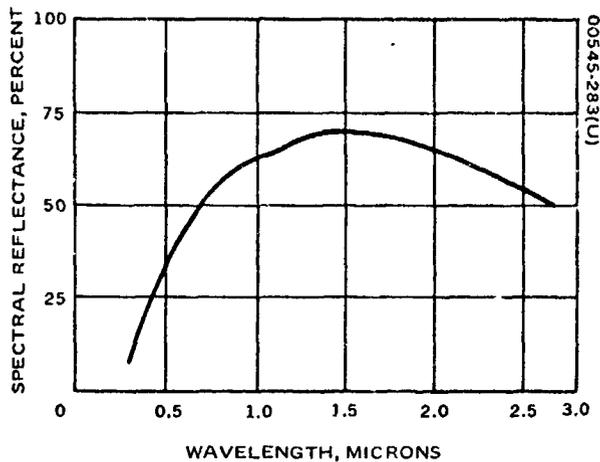
The four test coupons were cut from the bracket, as shown in Figure J-21. Each sample was 1 by 2 cm. The spectral reflectance of these four coupons was measured. One sample, 518 in Figure J-21, was examined with a scanning electron microscope for the presence of lunar soil. Lunar material could not be distinguished from the paint. This was due to the charge buildup in the paint and lunar soil. All samples were then stored in the dark for 3-1/2 months, after which the spectral reflectance was remeasured. The original measurements of spectral reflectance versus wavelength conducted in May 1970 on one of the above samples, 518 mentioned above, are plotted in Figure J-22. Results obtained 3-1/2 months later in August 1970 showed no appreciable change. Results of spectral

Figure J-22. Spectral Reflectance Versus Wavelength of Sample of Camera Cable Bracket: Sample 518 of Figure J-21: Measurements Taken in May 1970 Prior to Light Exposure

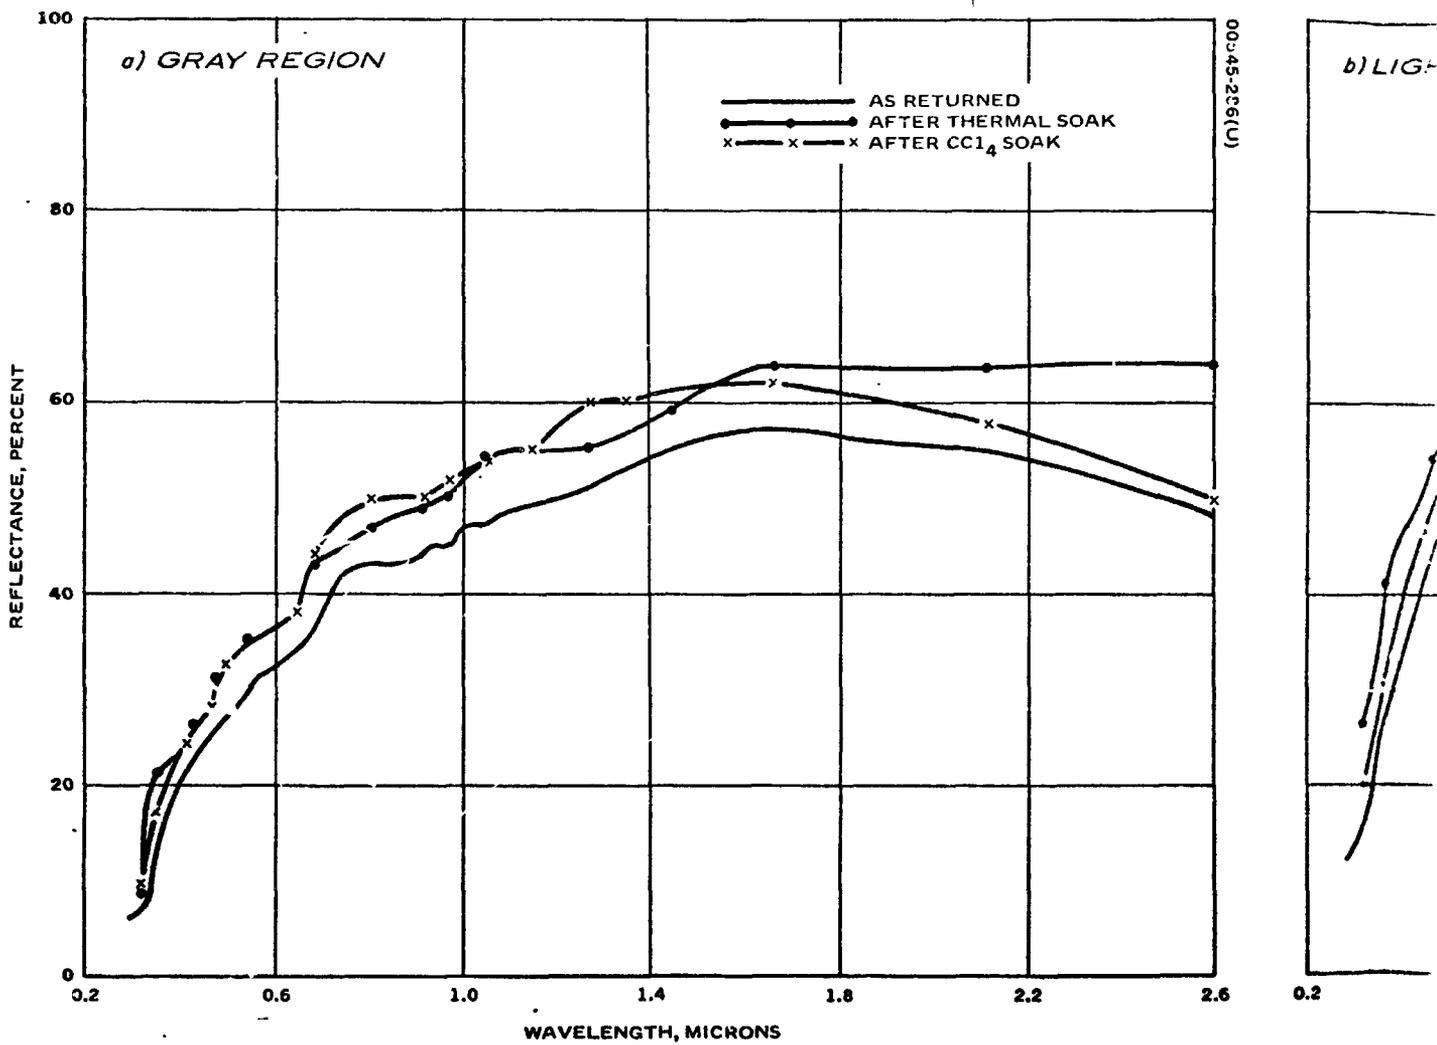
The spectral reflectance of the tube was measured by mounting the tube vertically in a Gier-Dunkle integrating sphere. The tube had three different colors. The general overall color of the tube was light yellow. A dark gray region was noted on the westerly side of the tube, and a very dark yellow region was found on the easterly side. The reflectance was measured in each of these regions.

Figure J-25. Reflectance of Bipod Bracket Tube

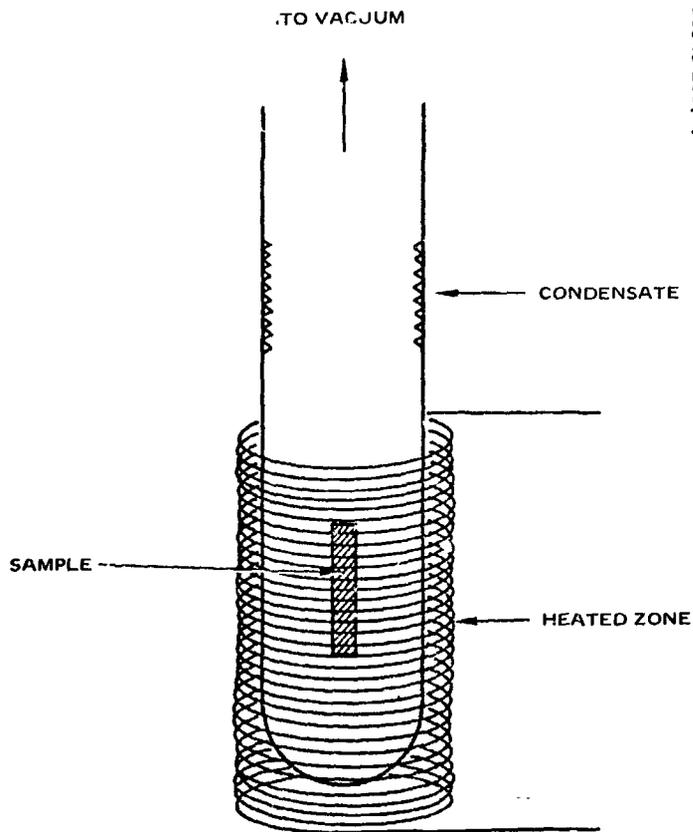
Figure J-26. Experimental Configuration for Thermal-Vacuum Exposure of Surveyor III Sample 909

The Surveyor III sample 909 outgassed a heavy but clear condensate during its thermal-vacuum exposure. This condensate appeared on the glass tube above the heated zone where the glass was at room temperature. The experimental configuration is shown in Figure J-26. No condensate was found on the glass tube where it had been heated. No condensate was found on the tube used to vacuum-thermal anneal the non-flight Surveyor inorganic white paint. The outgassing of sample 909 was due to the black organic paint. This paint has a history of high outgassing and is not used on current designs where outgassing limits are imposed.

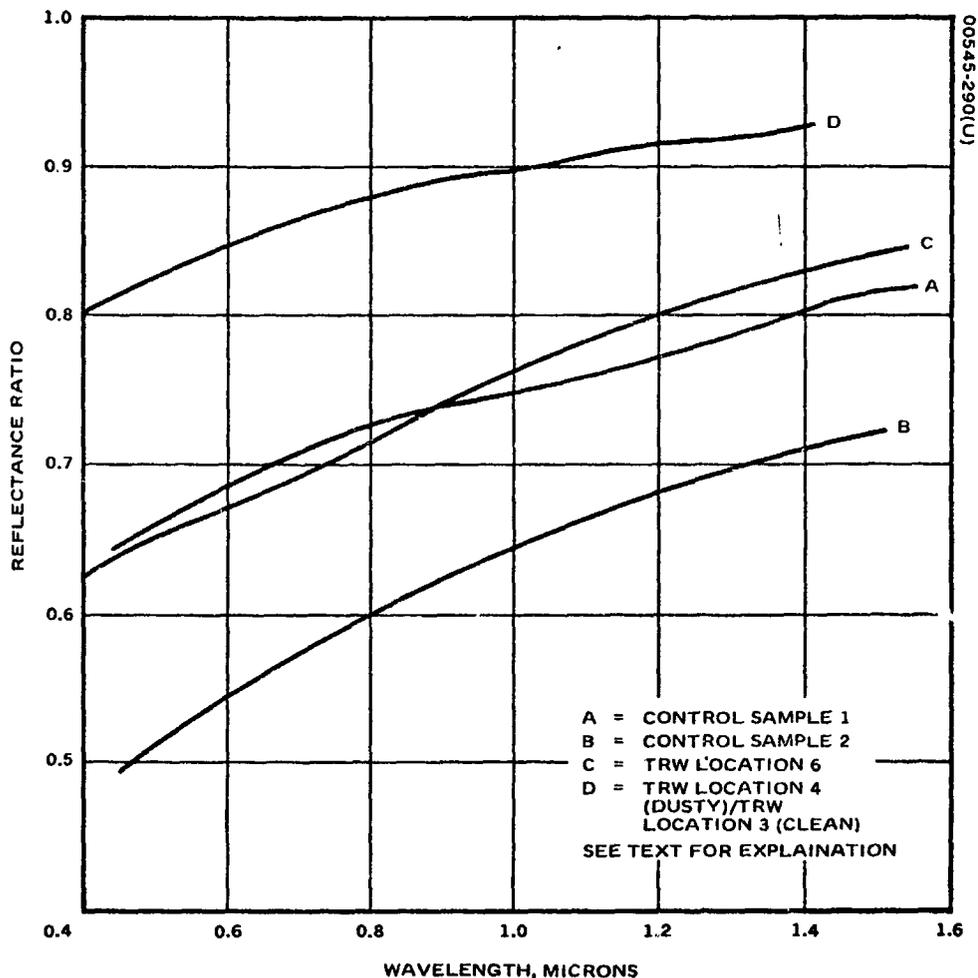
Figure J-27 shows the results of measurements by D. Nash (JPL), discussed in Reference 114, using Apollo XI fines on control samples of Surveyor coatings. The curves are plotted as a ratio of reflectance of surfaces covered with lunar dust, ρ_m , to reflectance of clean surfaces, ρ_o . From

Figure J-27. Ratio of Reflectance of Painted Surfaces Covered With Lunar Dust to the Reflectance of Clean Surfaces (White Inorganic Paint)

Also shown for comparison are results of measurements of samples from Surveyor III surfaces. The ratio ρ_m/ρ_0 is plotted for the sample from TRW position 6,* using the clean undegraded reflectance of TRW position 1 under the connector bracket as ρ_0 . Position 6 showed very little or no radiation effect; the discoloration was clearly due to dust. The difference between control sample 1 (curve A in Figure J-27) and TRW sample 6 (curve C) in the near-infrared was probably due to the differences in the reflectance of the paint, discussed above.
